BPG Inspection, LLC

**1930 Conner Street
Noblesville IN 46060**

Client(s): Anderson
Inspection Date: 10/30/2024
Inspector: Rob Rehm , HI00500115 (IN)

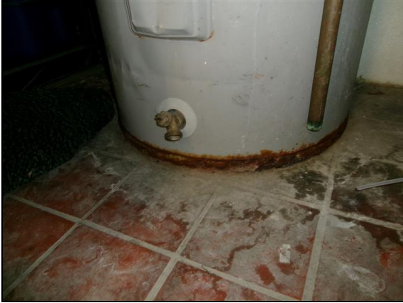
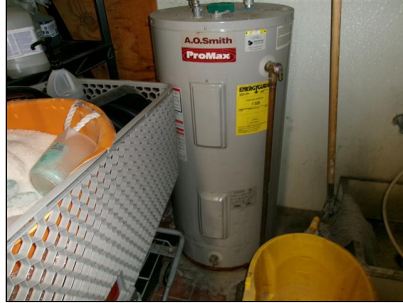
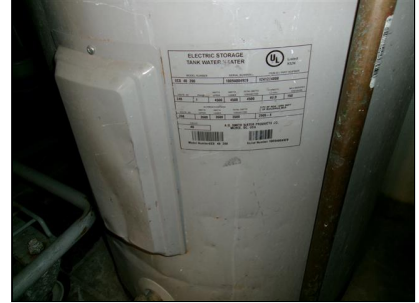
- ❌ 1. The electric water heater is functional, but is existing beyond its expected useful life and has rusting at the outer bottom of the tank. Recommend the water heater be replaced. Item 1(Picture) Item 2(Picture) Item 3(Picture)
Estimated cost to cure: \$1,400 - \$1,500

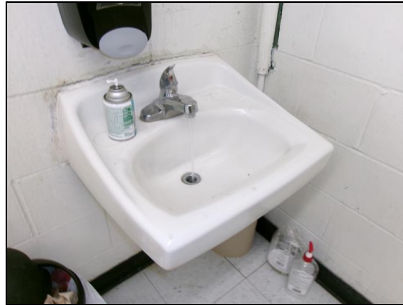
- ❌ 2. The sink at the men's bathroom in employee break room is falling loose from the wall. Have a plumber repair to prevent further damage. Item 1(Picture) Estimated cost to cure: \$300 - \$400

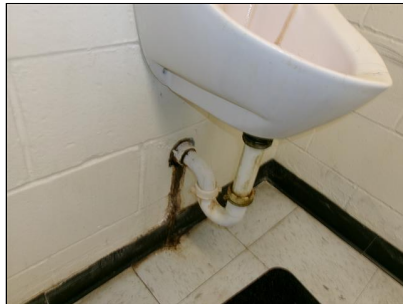
- ❌ 3. The urinal at the men's bathroom in the employee break room has a leaky drain pipe. A plumber should repair the leak as needed. Item 1(Picture) Estimated cost to cure: \$400 - \$500

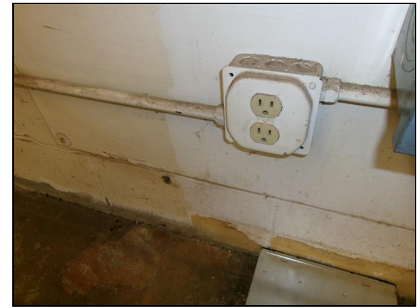
- ✖ 5. There are electrical outlets in the employee break room and at the rear NW warehouse storage room that are inoperative. This could be due to some breakers are shut off at the panel boxes. Resetting breakers is outside the scope of the inspection. Have an electrician evaluate and correct as needed. Item 1(Picture) Item 2(Picture) Item 3(Picture)

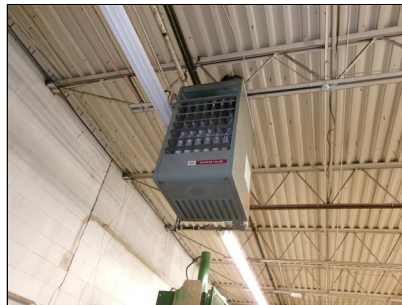
- ✖ 6. There are two ceiling mounted gas heaters in the rear NE warehouse storage room. One of these heaters has been disconnected and is no longer functional. Have a qualified HVAC contractor replace the heater as needed. Item 1(Picture) Estimated cost to cure: \$3,000 - \$4,000

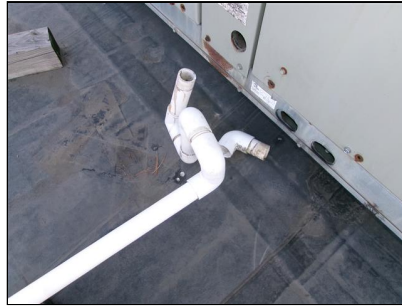
- ✖ 7. The condensate drain pipe at the roof top HVAC unit is damaged and disconnected. A qualified contractor should repair. Item 1(Picture) Estimated cost to cure: \$400 - \$500

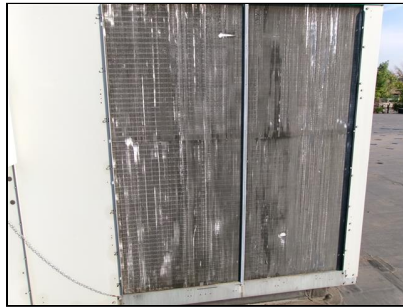
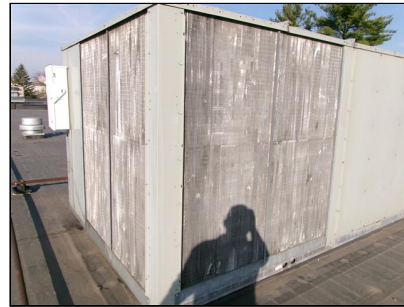
- ❌ 8. The cooling fins on root top HVAC unit are bent and damaged and appear to be hail damage. Have a HVAC company review at this time and repair/replace the fins as necessary. We recommend installation of hail guards as part of the repair process. Estimated cost to cure: \$900 to comb out the fins, if not possible then \$3,000 replace the fins. For older units expect contractors to possibly recommend replacement of the entire RTU. Item 1(Picture) Item 2(Picture)

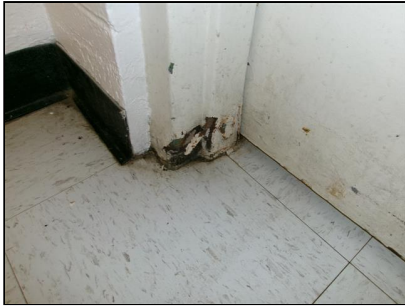
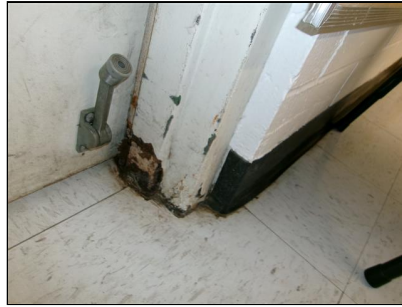
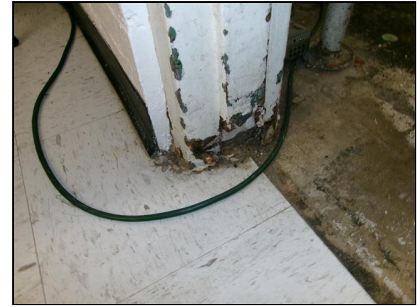
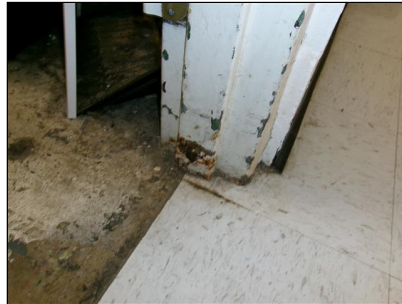
- ❌ 9. The bottom of metal door jambs in the employee break area are rusted or damaged and will need repair. Item 3(Picture) Item 4(Picture) Item 5(Picture) Estimated cost to cure: \$500 - \$600

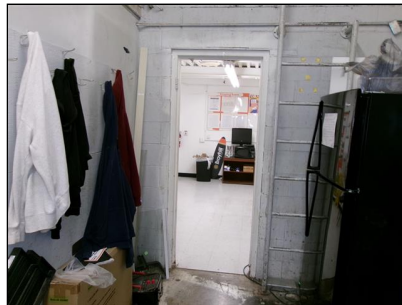
- ❌ 10. The door to the employee breaker room is missing and will need replaced. Item 7(Picture) Estimated cost to cure: \$1,000 - \$1,200

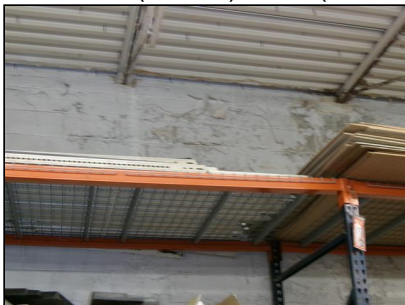
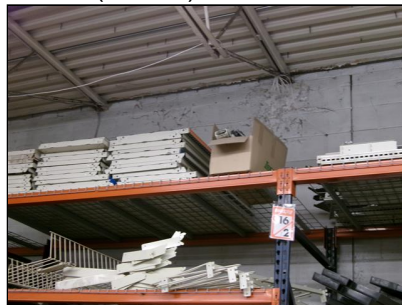
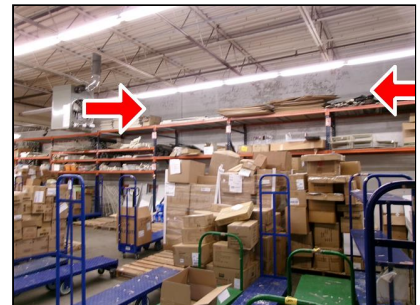
- ❌ 11. Some of the concrete block walls at the north end of the warehouse have peeling paint. Prep and repaint as needed. Item 8(Picture) Item 9(Picture) Item 10(Picture) Estimated cost to cure: \$1,200 - \$2,000

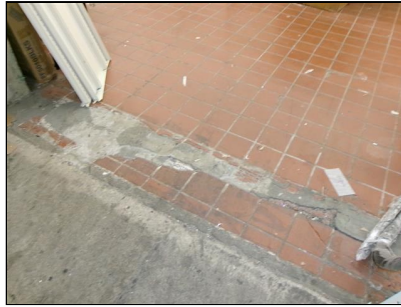
- ❌ 12. There is a small area of damaged ceramic floor tiles in the warehouse storage area. Replace tiles as needed. Item 11(Picture) Estimated cost to cure: \$1,000 - \$1,500

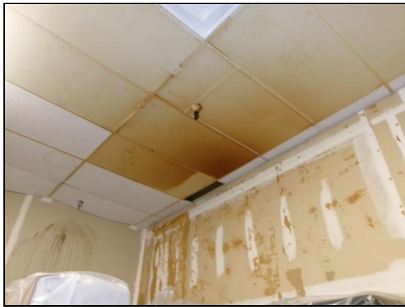
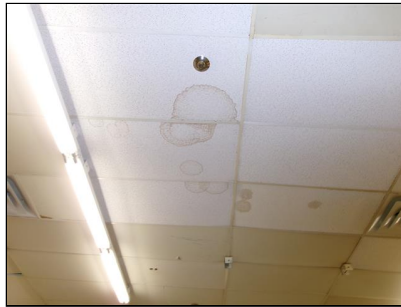
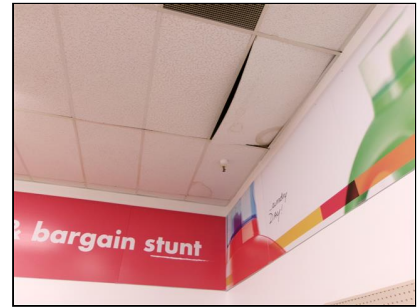
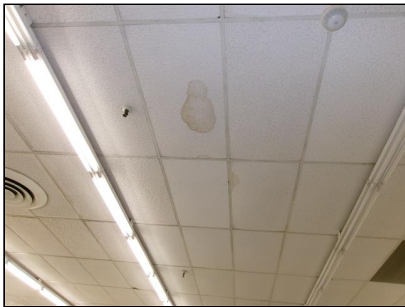
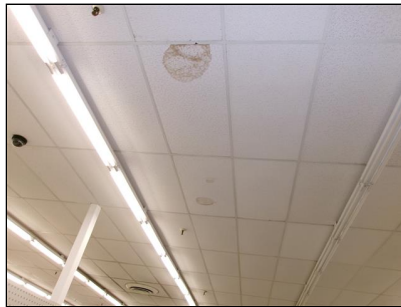
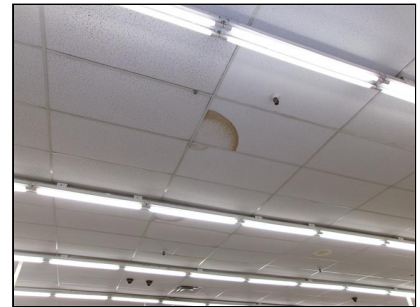
- ❌ 13. There are isolated drop down ceiling tiles through the interior of the building that are water stained or damaged. Replace tiles where needed. Item 12(Picture) Item 13(Picture) Item 14(Picture) Item 15(Picture) Item 16(Picture) Item 17(Picture) Estimated cost to cure: \$1,500 - \$2,500

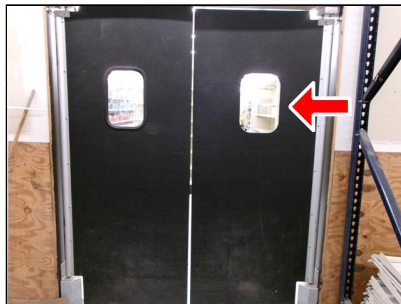
- ❌ 14. Plexiglass is missing at one of the swinging doors to the warehouse entry. Repair/replace door as needed. Item 18(Picture) Estimated cost to cure: \$300 - \$400

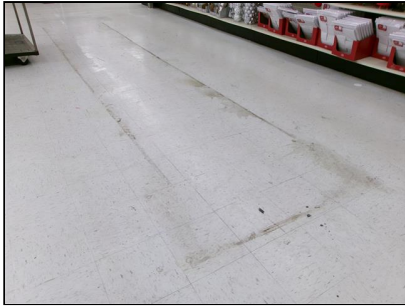
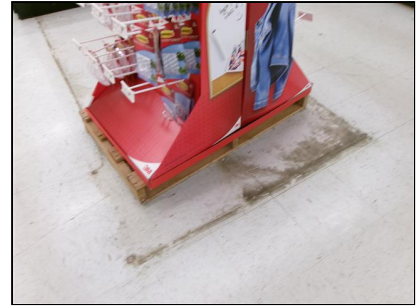
- ❌ 15. There are isolated vinyl floor tiles through out the retail area that are stained and have some surface damage. Repair or replace tiles as needed. Item 19(Picture) Item 20(Picture) Item 21(Picture) Item 22(Picture) Item 23(Picture) Estimated cost to cure will depend on work performed. Stripping and refinishing this type of flooring you can expect a cost of an estimated \$2.00 per square foot.

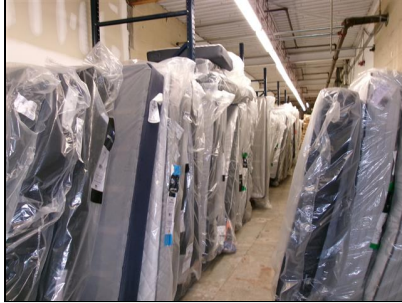
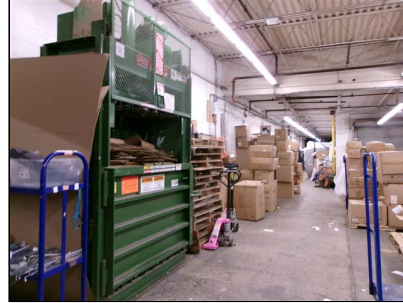
16. Interior inspection is limited due to stored items. Item 1(Picture) Item 2(Picture)

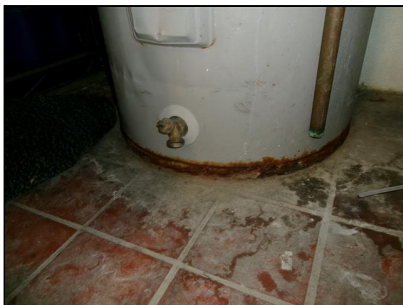
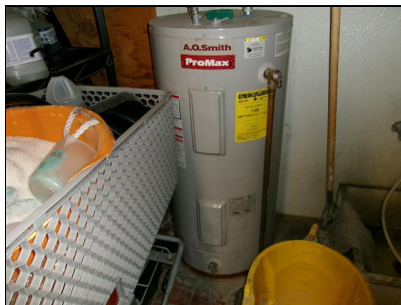
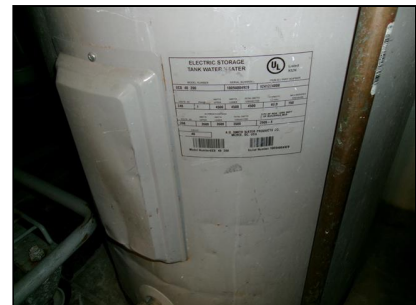
- ☒ ♦ The electric water heater is functional, but is existing beyond its expected useful life and has rusting at the outer bottom of the tank. Recommend the water heater be replaced. Item 1(Picture) Item 2(Picture) Item 3(Picture)
Estimated cost to cure: \$1,400 - \$1,500

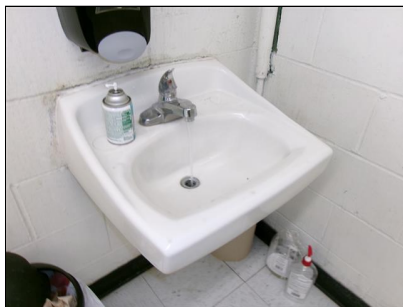
- ❌ ♦ The sink at the men's bathroom in employee break room is falling loose from the wall. Have a plumber repair to prevent further damage. Item 1(Picture) Estimated cost to cure: \$300 - \$400

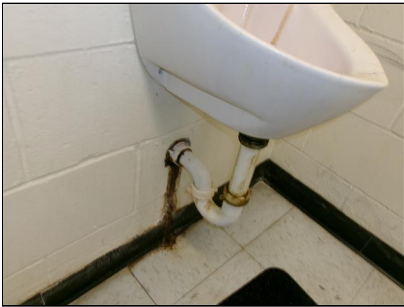
- ❌ ♦ The urinal at the men's bathroom in the employee break room has a leaky drain pipe. A plumber should repair the leak as needed. Item 1(Picture) Estimated cost to cure: \$400 - \$500

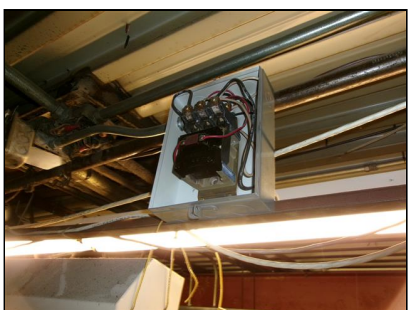
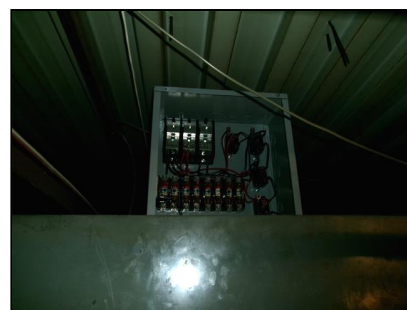
- ✗ ◆ There are at least three open electric junction boxes at the ceiling in the upper former compressor room. Cover plates should be installed at all open electric boxes for safety. Item 1(Picture) Item 2(Picture) Item 3(Picture)
Estimated cost to cure: \$300 - \$400

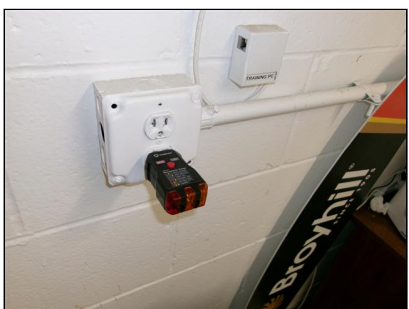
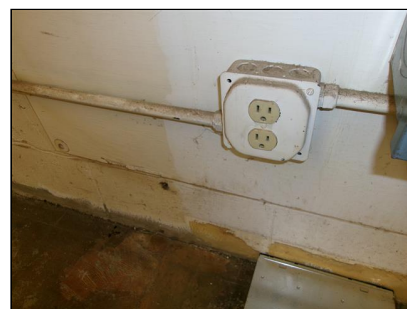
- ◆ Outlets behind equipment or otherwise inaccessible were not checked.
- ✗ ◆ There are electrical outlets in the employee break room and at the rear NW warehouse storage room that are inoperative. This could be due to some breakers are shut off at the panel boxes. Resetting breakers is outside the scope of the inspection. Have an electrician evaluate and correct as needed. Item 1(Picture) Item 2(Picture) Item 3(Picture)

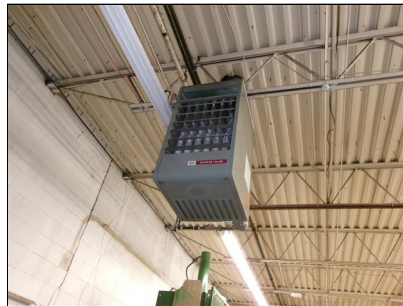
- ❌ ◆ There are two ceiling mounted gas heaters in the rear NE warehouse storage room. One of these heaters has been disconnected and is no longer functional. Have a qualified HVAC contractor replace the heater as needed. Item 1(Picture) Estimated cost to cure: \$3,000 - \$4,000

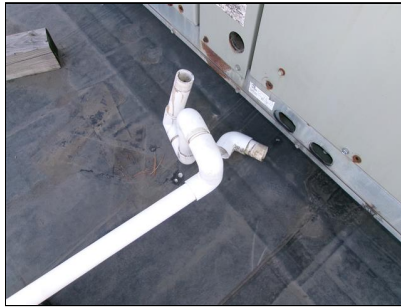
- ❌ ♦ The condensate drain pipe at the roof top HVAC unit is damaged and disconnected. A qualified contractor should repair. Item 1(Picture) Estimated cost to cure: \$400 - \$500

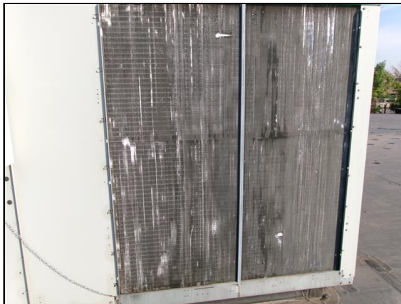
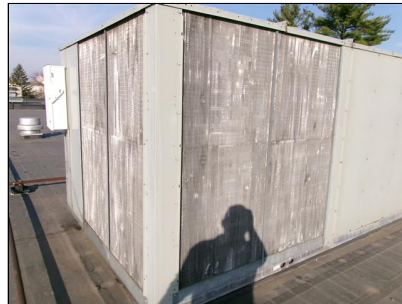
- ❌ ♦ The cooling fins on root top HVAC unit are bent and damaged and appear to be hail damage. Have a HVAC company review at this time and repair/replace the fins as necessary. We recommend installation of hail guards as part of the repair process. Estimated cost to cure: \$900 to comb out the fins, if not possible then \$3,000 replace the fins. For older units expect contractors to possibly recommend replacement of the entire RTU. Item 1(Picture) Item 2(Picture)

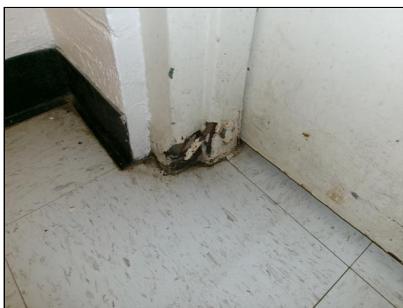
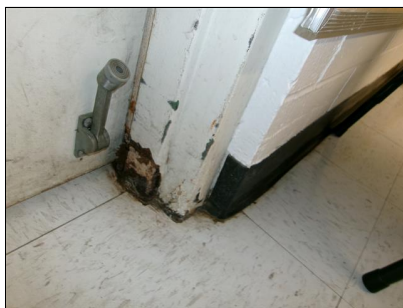
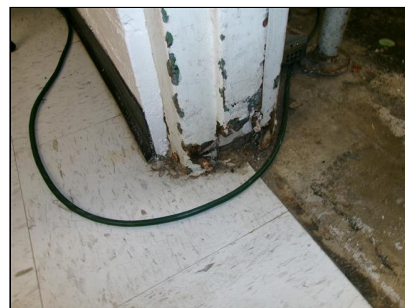
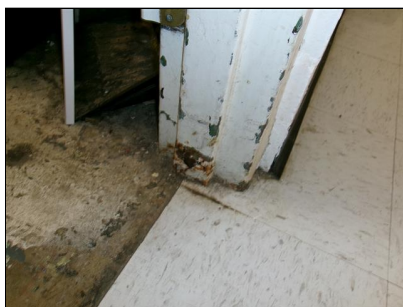
♦ The bottom of metal door jambs in the employee break area are rusted or damaged and will need repair. Item 3(Picture) Item 4(Picture) Item 5(Picture) Estimated cost to cure: \$500 - \$600

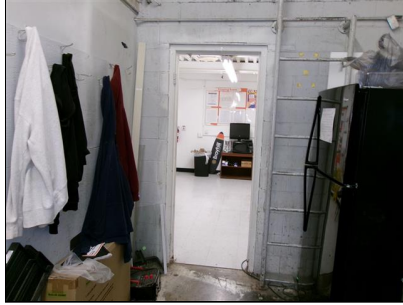
♦ The door to the employee breaker room is missing and will need replaced. Item 7(Picture) Estimated cost to cure: \$1,000 - \$1,200

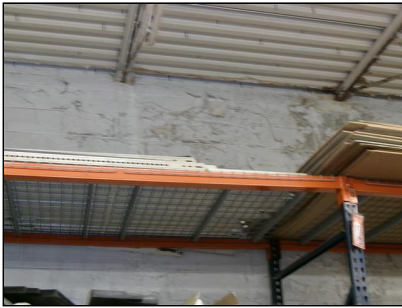
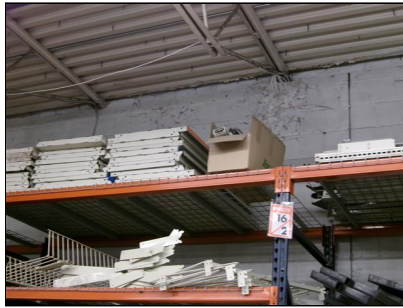
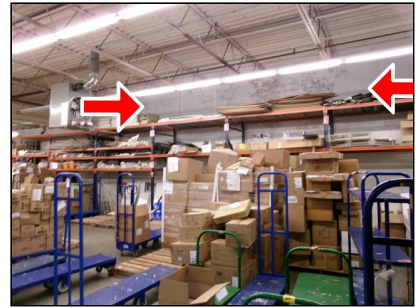
- ❌ ♦ Some of the concrete block walls at the north end of the warehouse have peeling paint. Prep and repaint as needed. Item 8(Picture) Item 9(Picture) Item 10(Picture) Estimated cost to cure: \$1,200 - \$2,000

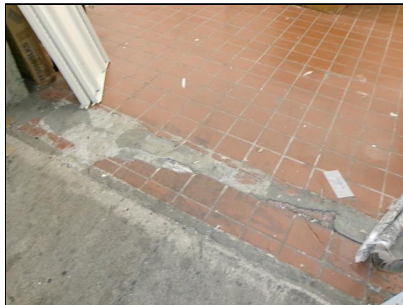
- ❌ ♦ There is a small area of damaged ceramic floor tiles in the warehouse storage area. Replace tiles as needed. Item 11(Picture) Estimated cost to cure: \$1,000 - \$1,500

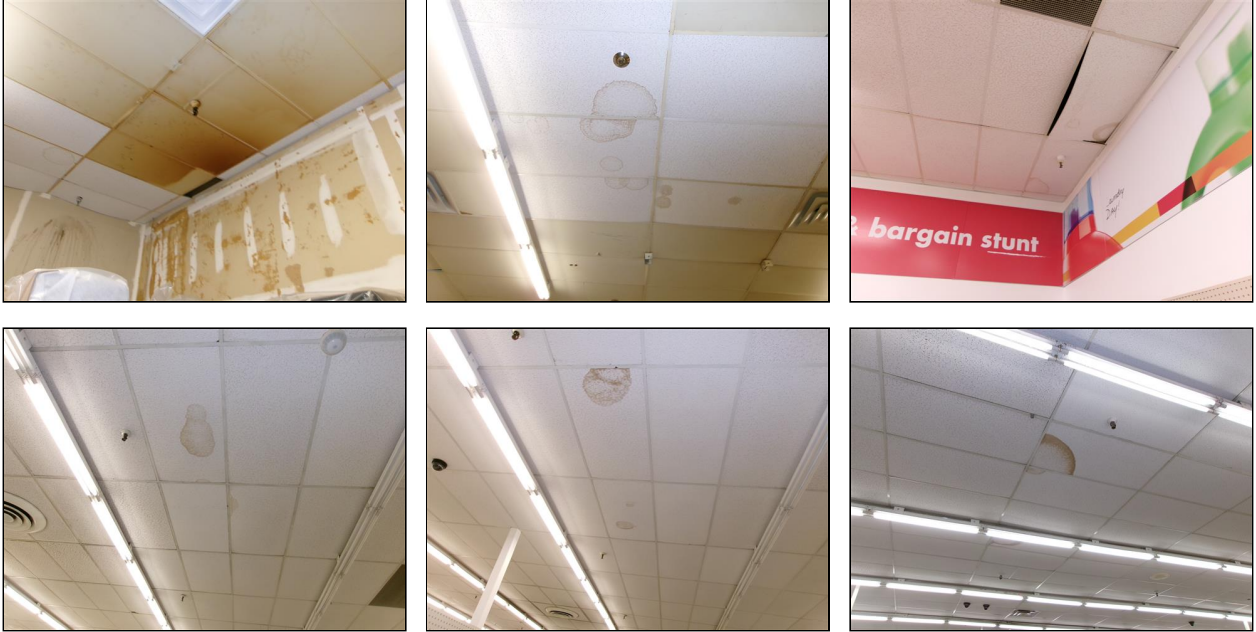
- ❌ ♦ There are isolated drop down ceiling tiles through the interior of the building that are water stained or damaged. Replace tiles where needed. Item 12(Picture) Item 13(Picture) Item 14(Picture) Item 15(Picture) Item 16(Picture) Item 17(Picture) Estimated cost to cure: \$1,500 - \$2,500

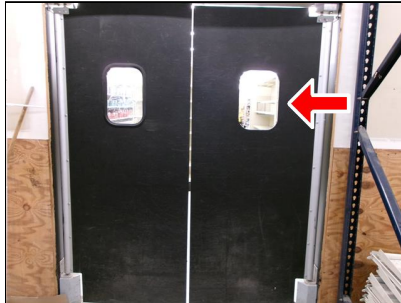
- ❌ ♦ Plexiglass is missing at one of the swinging doors to the warehouse entry. Repair/replace door as needed. Item 18(Picture) Estimated cost to cure: \$300 - \$400

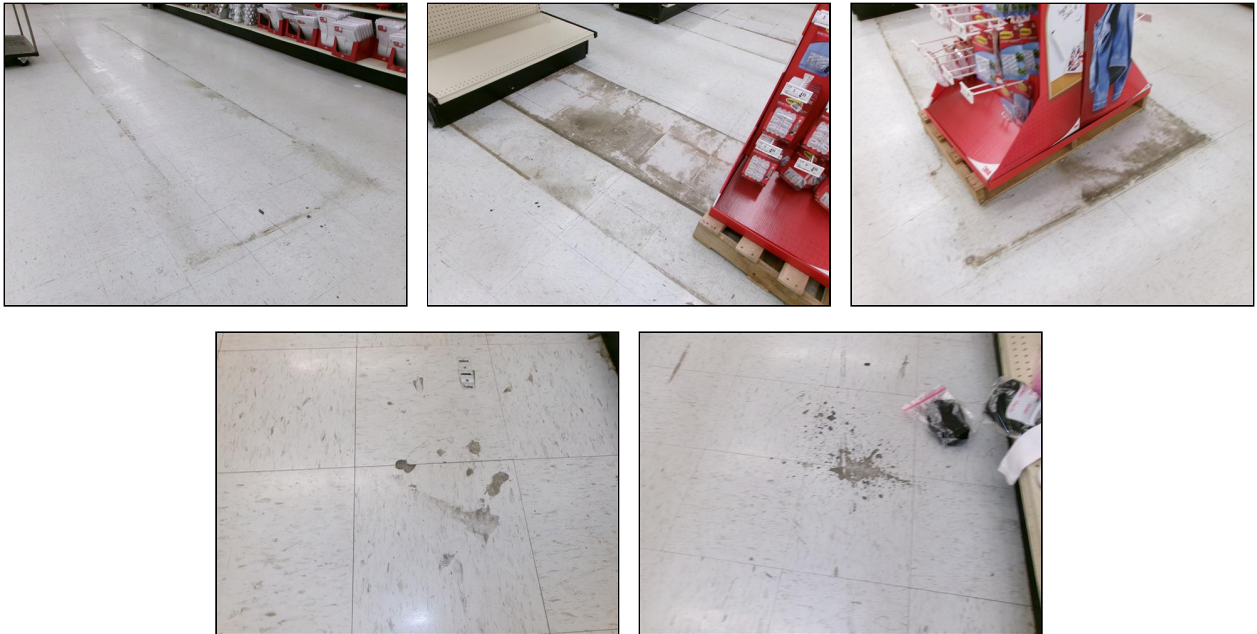
- ❌ ♦ There are isolated vinyl floor tiles through out the retail area that are stained and have some surface damage. Repair or replace tiles as needed. Item 19(Picture) Item 20(Picture) Item 21(Picture) Item 22(Picture) Item 23(Picture) Estimated cost to cure will depend on work performed. Stripping and refinishing this type of flooring you can expect a cost of an estimated \$2.00 per square foot.
